A Property Inspection Report
prepared for:

David and Sharon French
2404 S. Pace Bend Road
Spicewood, TX 78669

Date of Inspection: February 14, 2009

PROPERTY INSPECTION REPORT

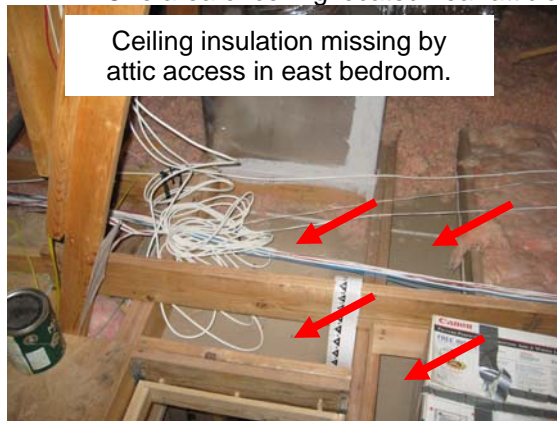
1. One area of ceiling located near attic access in east bedroom was missing insulation.

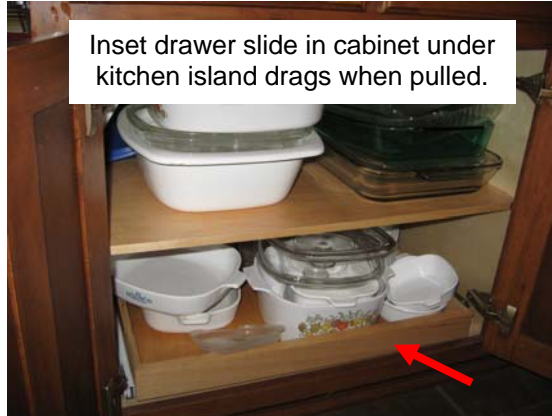
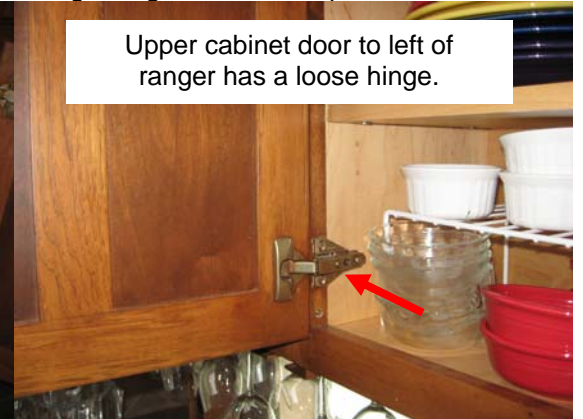
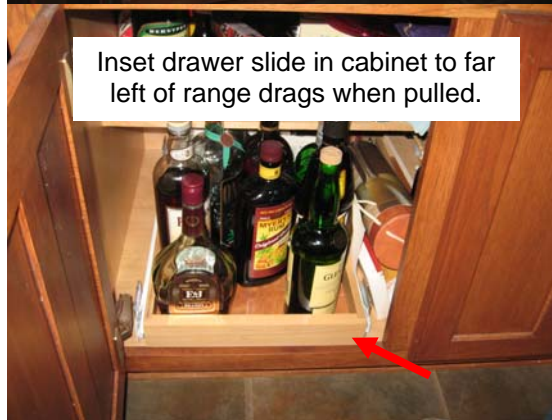
1. Inset drawer slide in cabinet under kitchen island drags a little when pulled.
2. Cabinet door to left of range has a loose hinge.
3. Inset drawer slide in cabinet to far left of range drags a little when pulled.

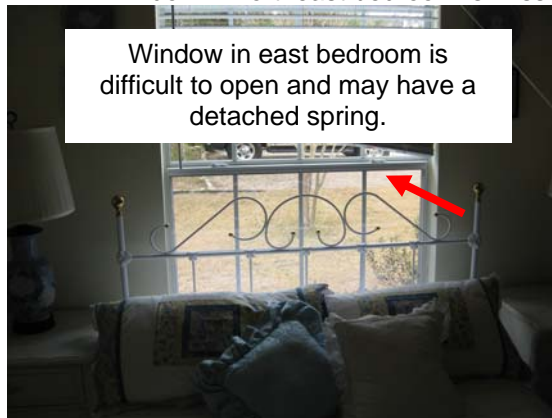
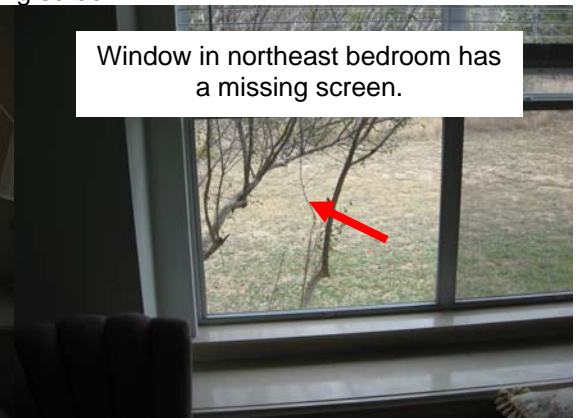
1. Window in east bedroom is difficult to open and may have a detached spring.
2. Window in northeast bedroom is missing screen.

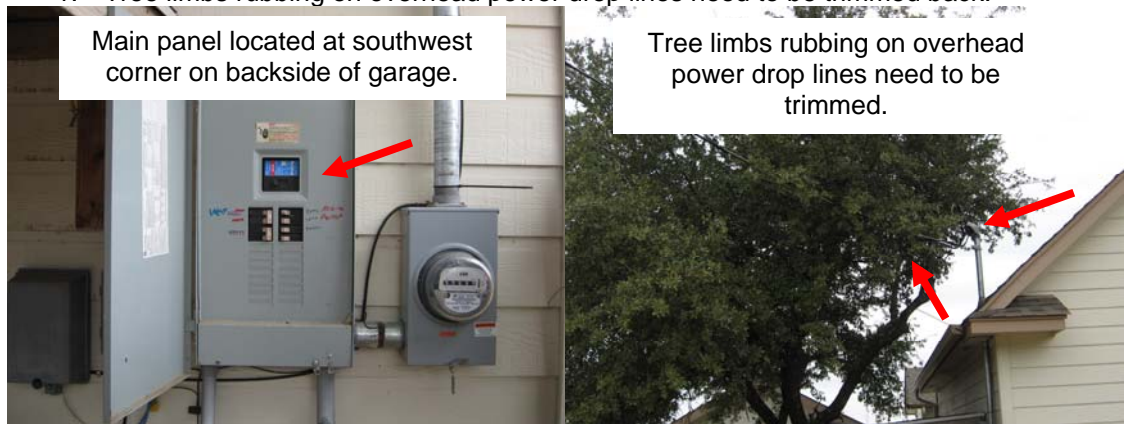
<i>Comments:</i> 120/240 volt, 200 amp service fed from an overhead drop from pole mounted transformer. Main panel located at southwest corner of property on backside of garage.

1. Tree limbs rubbing on overhead power drop lines need to be trimmed back. |

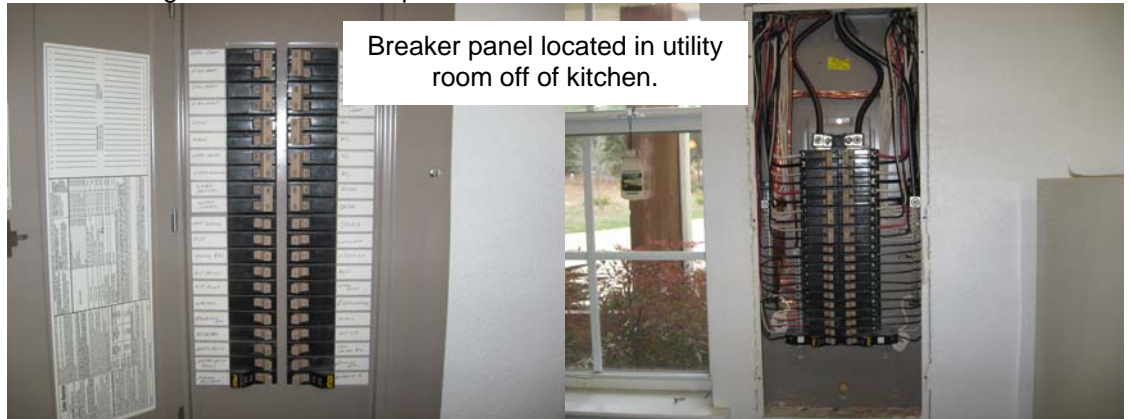
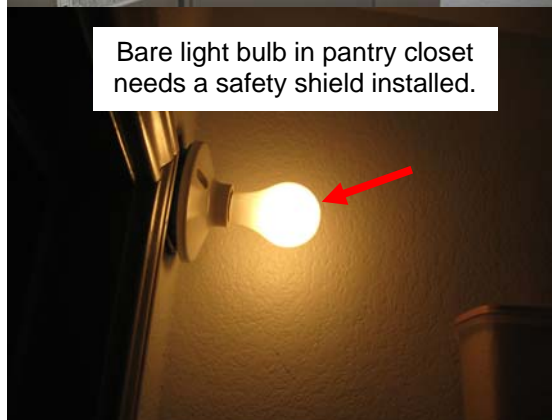
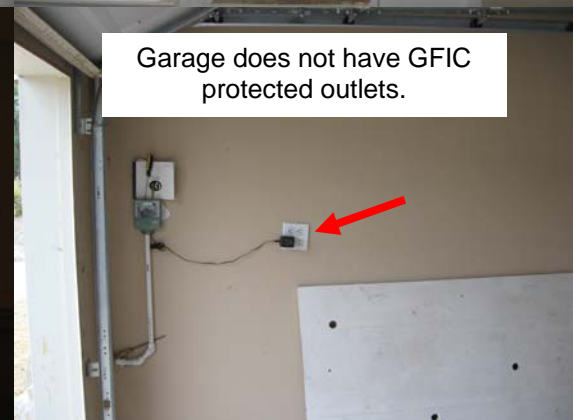
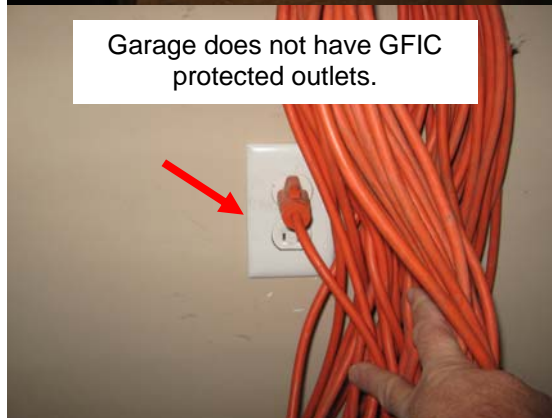
1. Panels checked for hot spots with digital infrared pyrometer and found no issues.
2. Light in pantry closet in kitchen needs a safety shield installed
3. Garage outlets not GFIC protected.
